Manhole Inspection Summary

Manhole # S19KK_024MH

Insp Date: **6/5/07 8:12 AM**

Location Address: **2018 CLIFTON AVE**

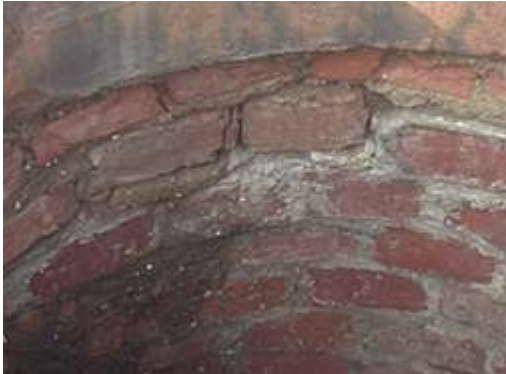
Defect 2

Condition: ☐ Sound ☒ **Cracked** ☐ Root Intrusion ☐ Loose Brick ☐ Deteriorated

CRACKS IN CHIMNEY

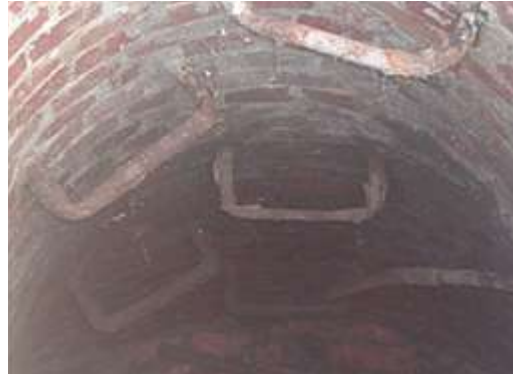
Defect 1

Steps Count: **5** Missing: **0** ☒ **Corroded**

CORRODED STEPS

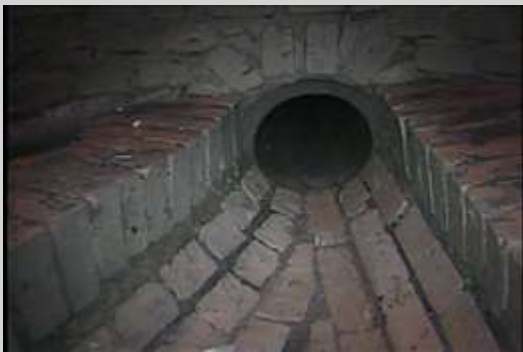
12 O'Clock Outflow

8 in. Circular Gravity Sewer
Pipe Out @ 12 O'Clock

Pipe Height: **8.4** (in.) Rod and Bar (Angled)
Pipe Material: **Clay** ☐ Pipe Lined
Invert Depth: **9.15** (ft.) Flow Characteristics: **Slow**
Deposits: ☒ None ☐ Mud ☐ Sludge ☐ Debris ☐ Grease
Silt Depth: (in.) Deposits Extent:
Infiltration: **None** Pipe Seal Cond: **Sound**

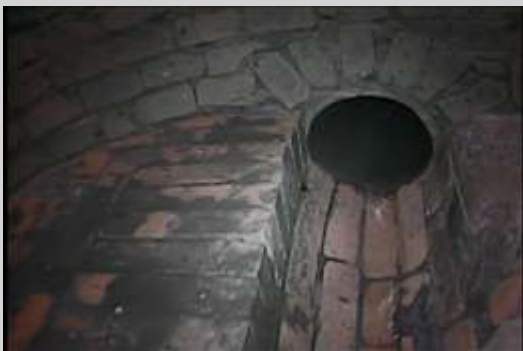
6 O'Clock Inflow

8 in. Circular Gravity Sewer
Pipe In @ 6 O'Clock

Pipe Height: **8.4** (in.) Rod and Bar (Angled)
Pipe Material: **Clay** ☐ Pipe Lined
Invert Depth: **8.76** (ft.) Flow Characteristics: **Slow**
Deposits: ☒ None ☐ Mud ☐ Sludge ☐ Debris ☐ Grease
Silt Depth: (in.) Deposits Extent:
Infiltration: **None** Pipe Seal Cond: **Sound**

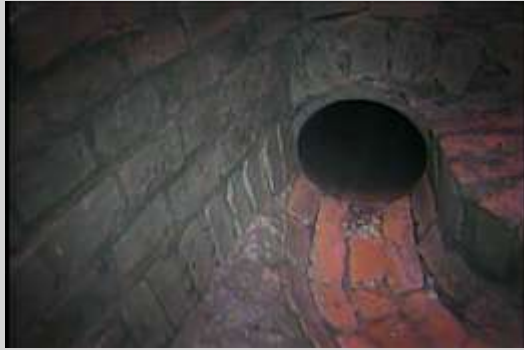
9 O'Clock Inflow

Pipe In @ 9 O'Clock

Infiltration: **None** Pipe Seal Cond: **Sound**
